DEPARTMENT OF TRANSPORTATION

Quality Assurance and Source Inspection

Contract #: 04-0120F4Cty: SF/ALA Rte: 80 PM: 13.2/13.9File #: 69.28**WELDING INSPECTION REPORT****Resident Engineer:**Siegenthaler, Peter**Address:** 333 Burma Road**City:** Oakland, CA 94607**Report No:** WIR-018393**Date Inspected:** 18-Nov-2010**Project Name:** SAS Superstructure**OSM Arrival Time:** 700**Prime Contractor:** American Bridge/Fluor Enterprises, a JV**OSM Departure Time:** 1900**Contractor:** Zhenhua Port Machinery Company, Ltd (ZPMC), Changxing Island **Location:** Shanghai, China**CWI Name:** Mr. Chen xi**CWI Present:** Yes No**Inspected CWI report:** Yes No N/A**Rod Oven in Use:** Yes No N/A**Electrode to specification:** Yes No N/A**Weld Procedures Followed:** Yes No N/A**Qualified Welders:** Yes No N/A**Verified Joint Fit-up:** Yes No N/A**Approved Drawings:** Yes No N/A**Approved WPS:** Yes No N/A**Delayed / Cancelled:** Yes No N/A**Bridge No:** 34-0006**Component:** Orthotropic Box Girder(OBG)**Summary of Items Observed:**

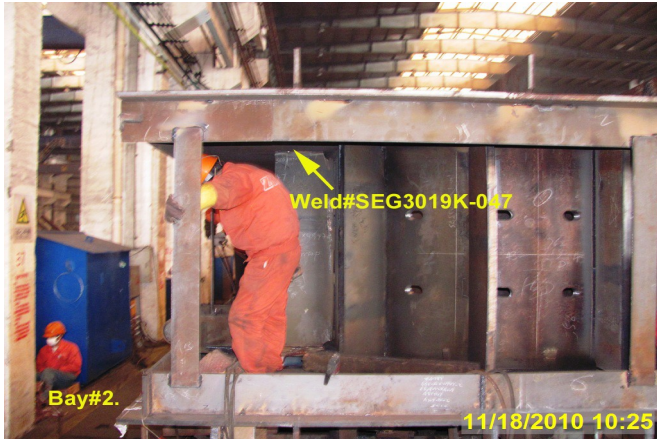
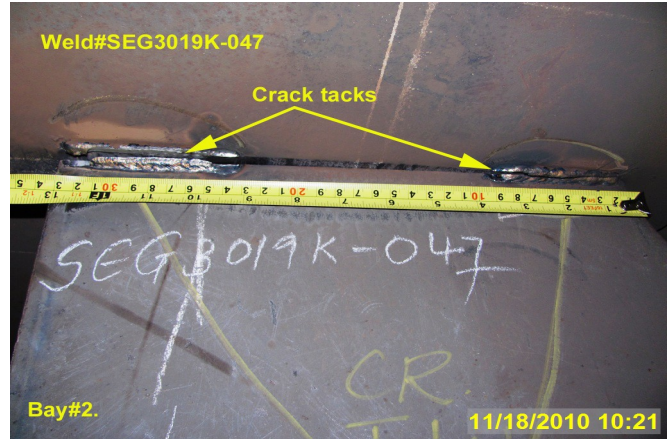
During random in process inspection of OBG member identified as SEG3019K this QA observed a cracked tack welds on weld joint identified as SEG3019K-047. This QA marked the cracked tacks and informed ZPMC Quality Control (QC) indentified as Mr. Xu jie of this issue. Mr. Xu jie informed this QA that the cracked tacks would be corrected in a manner compliant with the contract documents. Refer the attached photos for reference.
